Analysis of Surveyor 3 material and photographs returned by Apollo 12

NATIONAL AERONAUTICS AND SPACE ADMINISTRATION

1972

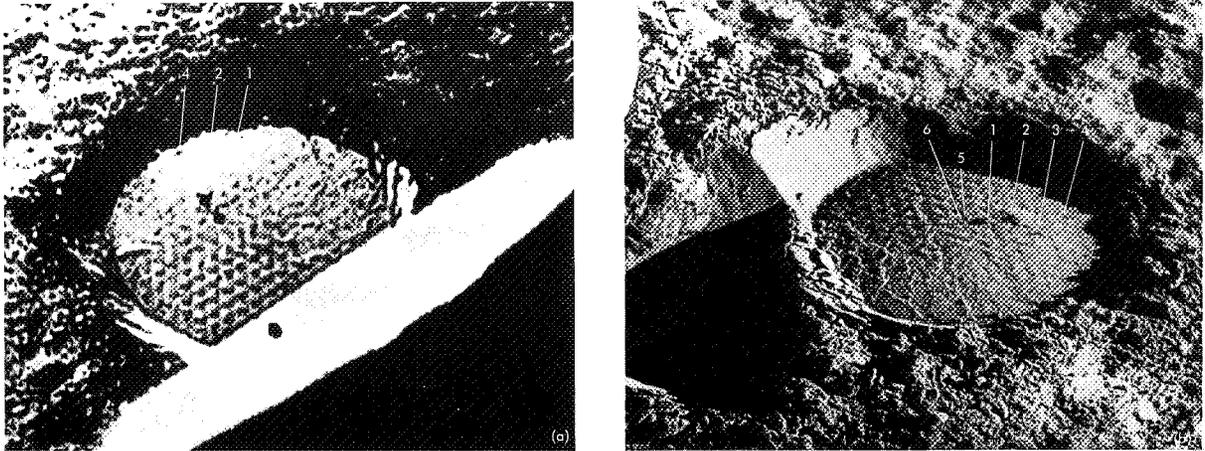
FIGURE 1.—Imprint in lunar soil made by footpad 2 of Surveyor 3. Waffle pattern in imprint is from the bottom of Surveyor footpad. (a) Part of Surveyor 3 television picture taken April 21, 1967, at 08:24:20 GMT. Sun is in the east, 27° above horizontal. View from north of west. Picture is digitally computer processed. (b) Part of photograph from Apollo 12 hand camera taken November 20, 1969, about 05:22 GMT. Sun is in the east, 23° above horizontal. View from south (from photograph AS12-48-7110). Numbers 1, 2 indicate two particles clearly visible on floor of imprint in each picture; 3 indicates a particle visible only in the Apollo photograph; 4 indicates a pit visible in both pictures; 5 indicates a pit visible in Apollo photograph, tentatively identified in the Surveyor picture; and 6 indicates a small particle next to pit 5.

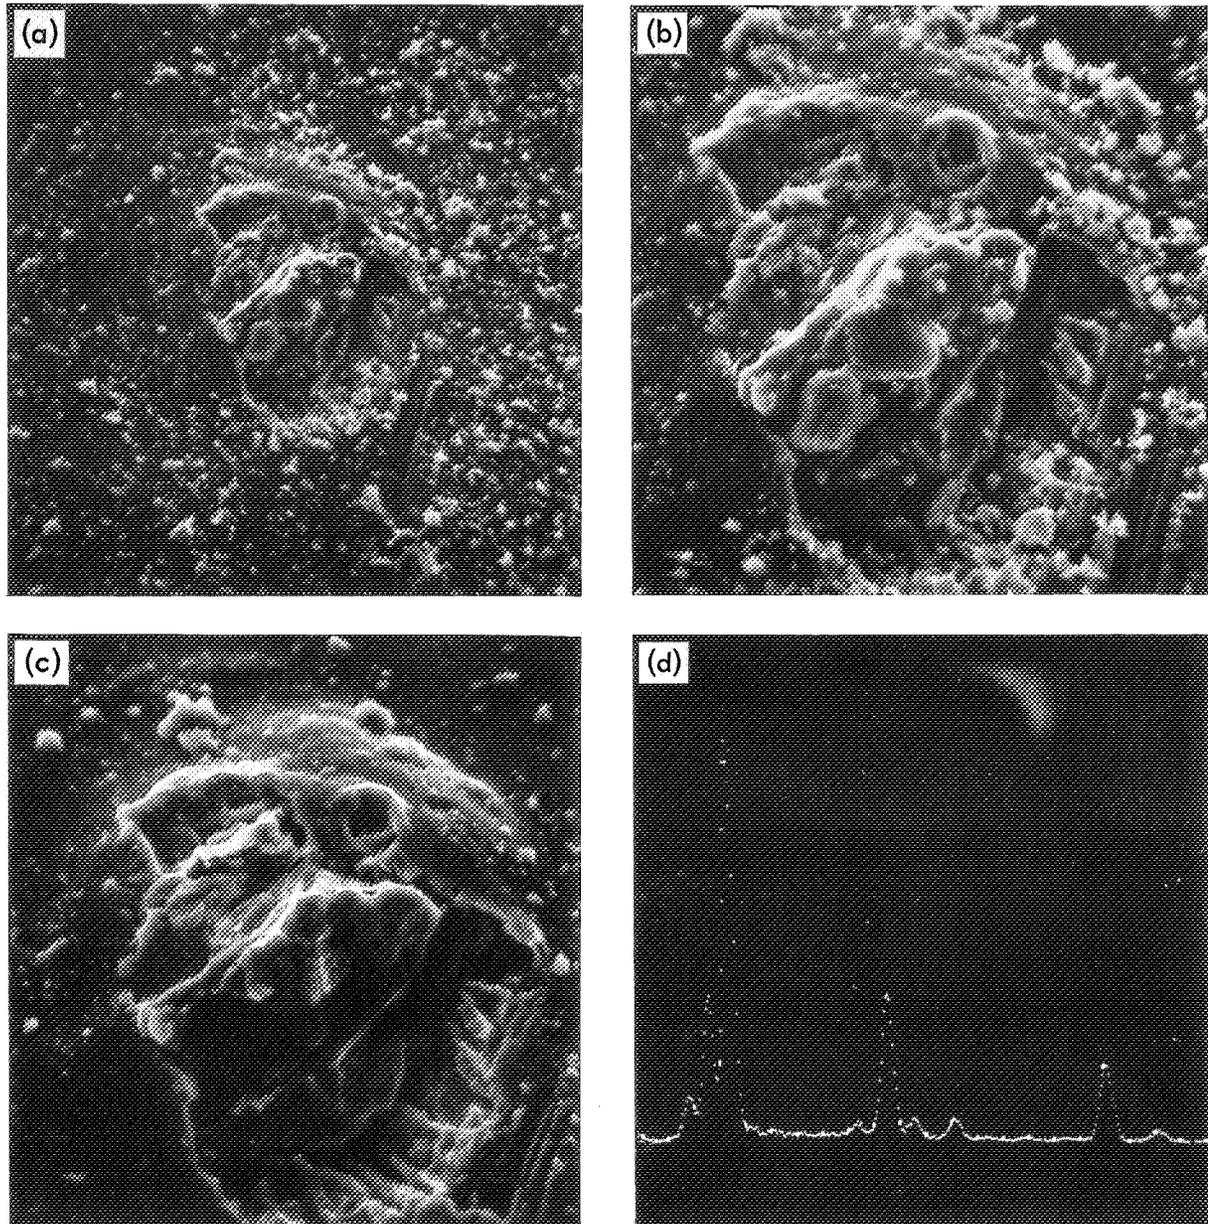
FIGURE 4.—Scanning electron micrograph of lunar dust embedded in bottom of lower shroud. (a) As received; 500 \times . (b) as received; 1000 \times . (c) after ultrasonic cleaning; 1000 \times . (d) spectrochemical analysis identified particle as pyroxene.

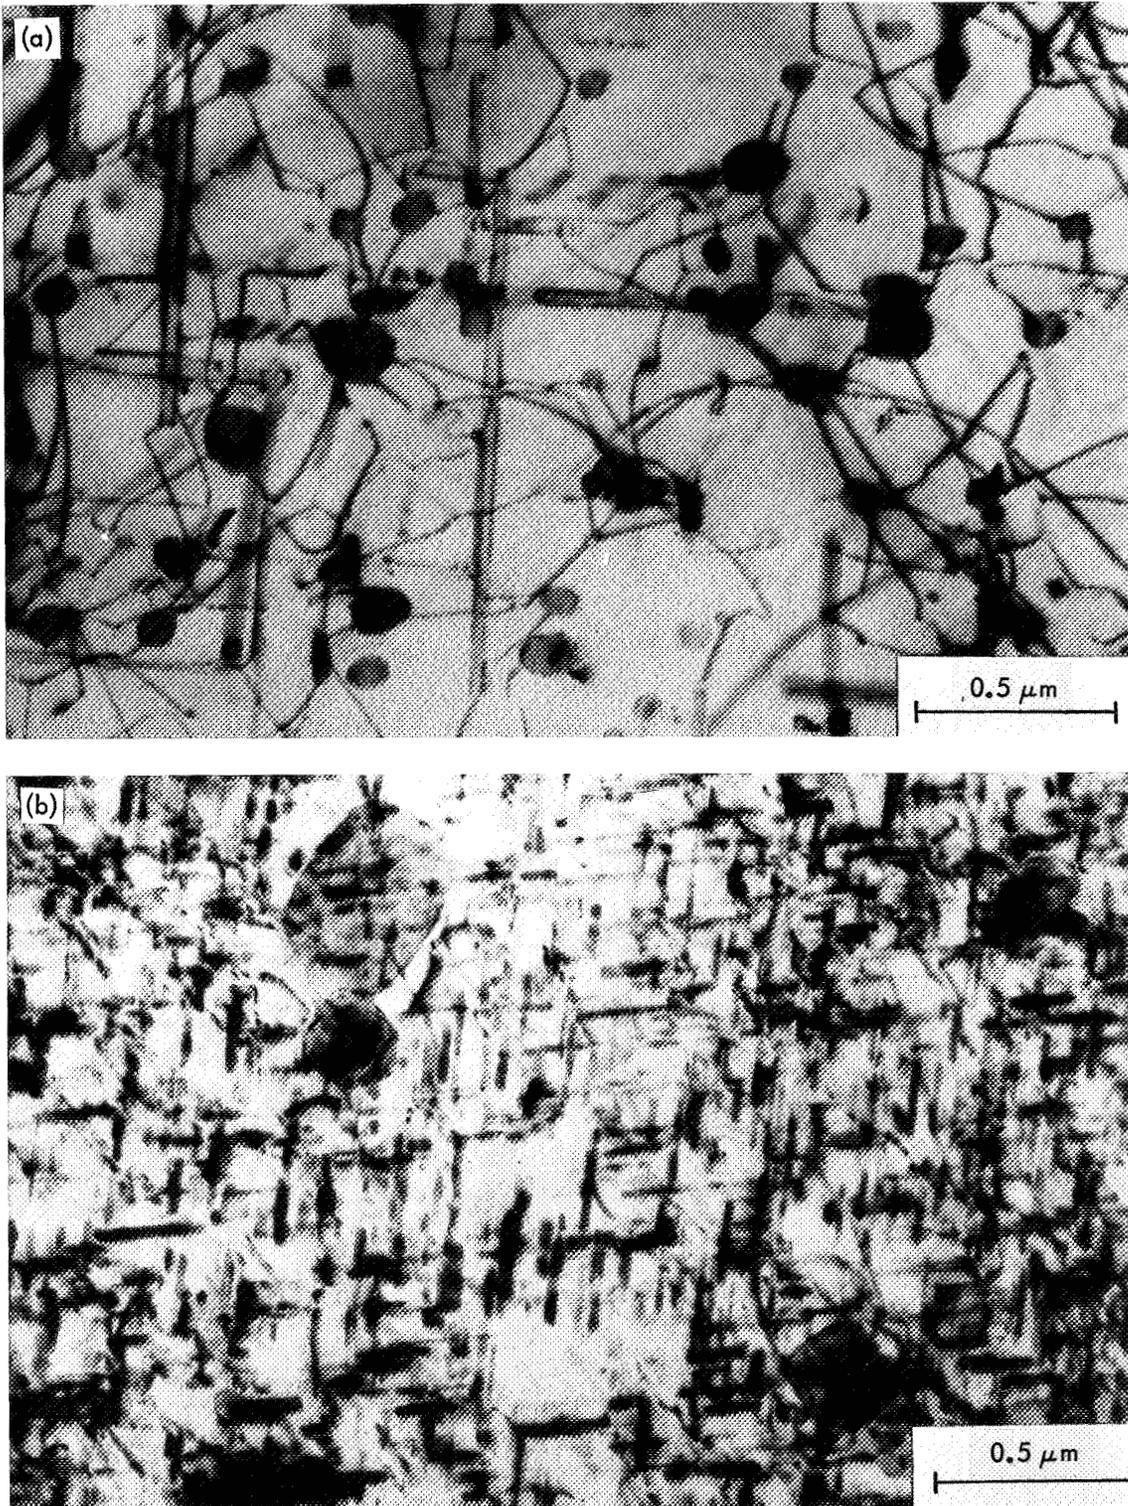
FIGURE 5.—High-voltage (1000 kV) transmission electron micrographs of Surveyor 3 camera shrouds. (a) Upper shroud visor: sample 933. (b) Lower shroud bottom: sample 934.

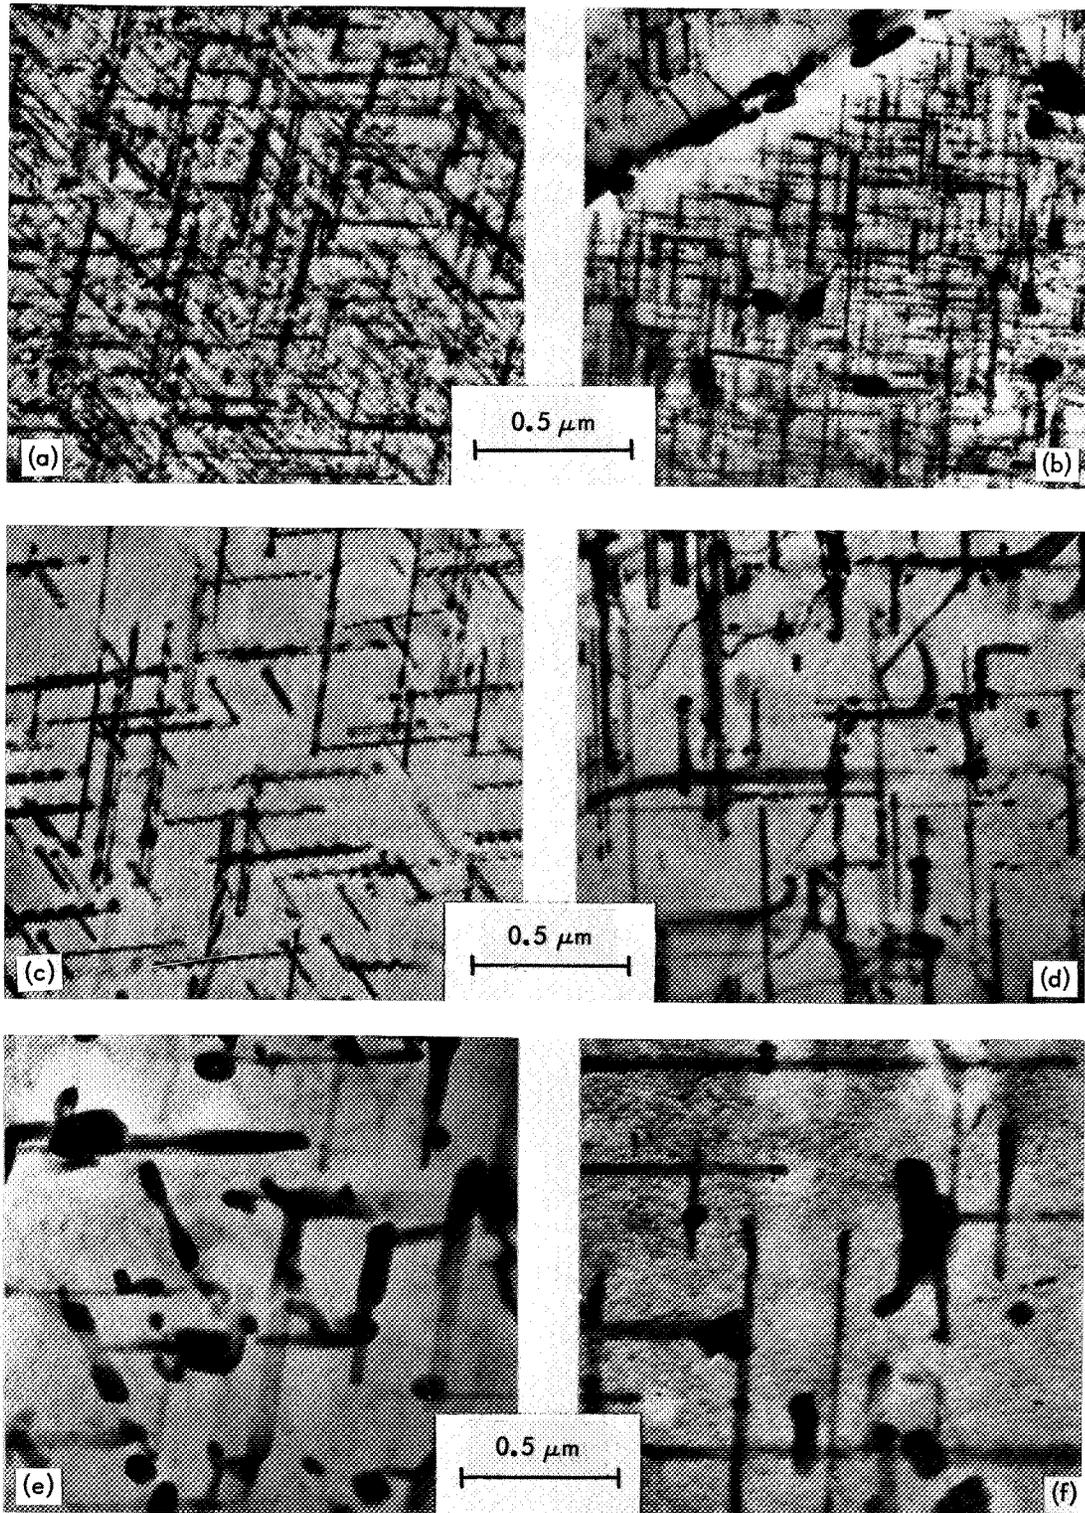
FIGURE 8.—Transmission electron micrographs of quench-aged samples of Al-Mg₂Si (Alloy 6061-T4). At 100 kV. (a) 175°C; 216 hr. (b) 250°C; 3 hr. (c) 300°C; 64 hr. (d) 325°C; 1 hr. (e) 350°C; 19 hr. (f) 375°C; 2¼ hr.

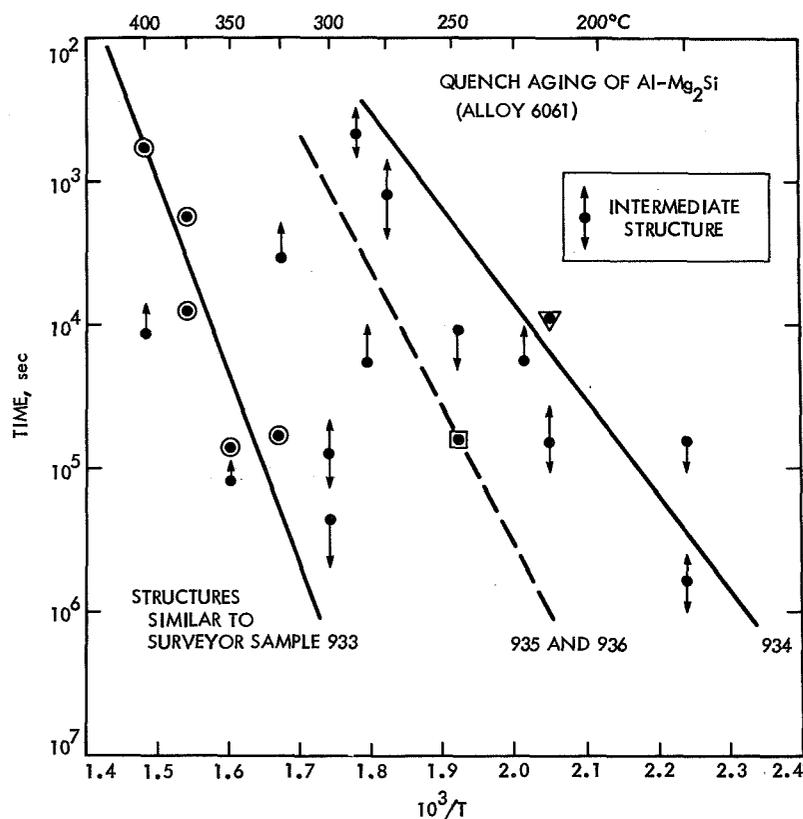
FIGURE 9.—Quench aging of Al- Mg_2Si to produce microstructures similar to those in samples of Surveyor 3 camera shrouds.

There was no evidence of microstructure effects caused by particle bombardment from the solar wind, solar flares, or cosmic radiation. The size and appearance of precipitate particles of Mg_2Si indicate appreciable thermal aging (which possibly occurred during fabrication). Elevated

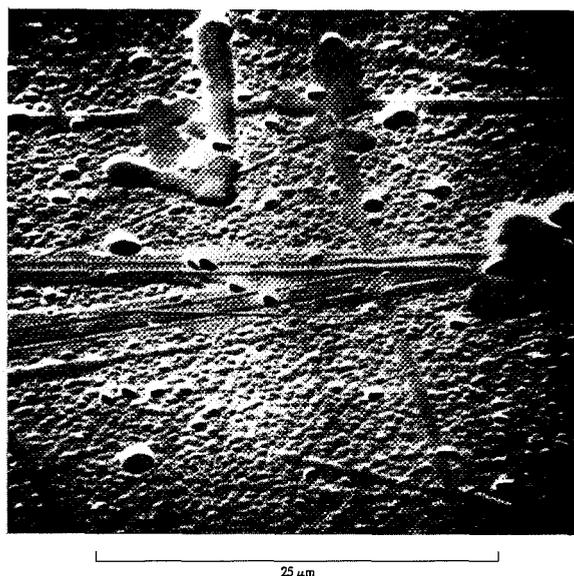
FIGURE 2.—Etched tracks on the top surface after removal of surface films. The tracks are the dark oval objects about 1 μm in size. They clearly point to the camera opening. The shallow pits also are found on the unirradiated part of the glass and are not produced by nuclear particles.

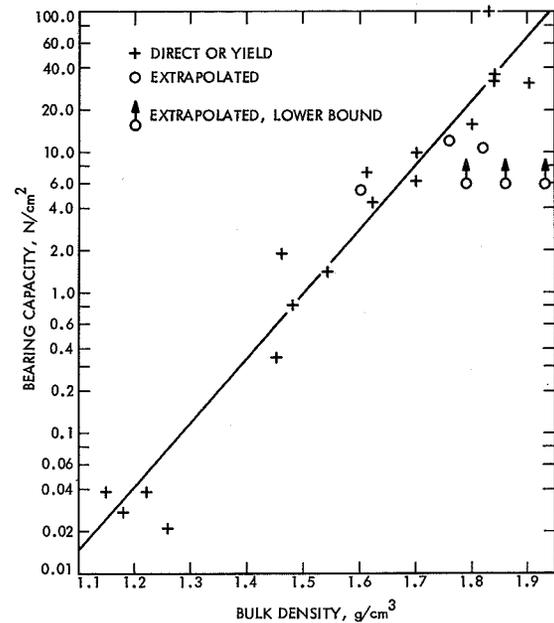
FIGURE 2.—Bearing capacity vs. bulk density. Line indicates least-squares fit. Bearing capacity was taken at a penetration equal to indenter diameter.

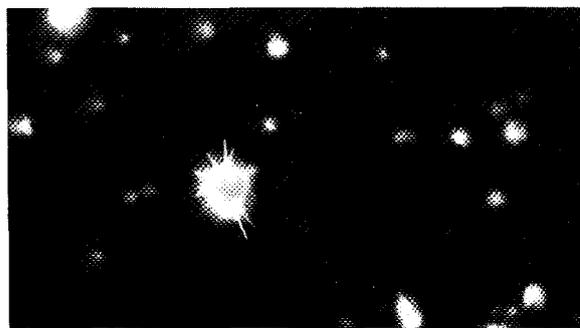
FIGURE 1.—Optical micrograph of a 6- μm nontransparent particle with whiskers.

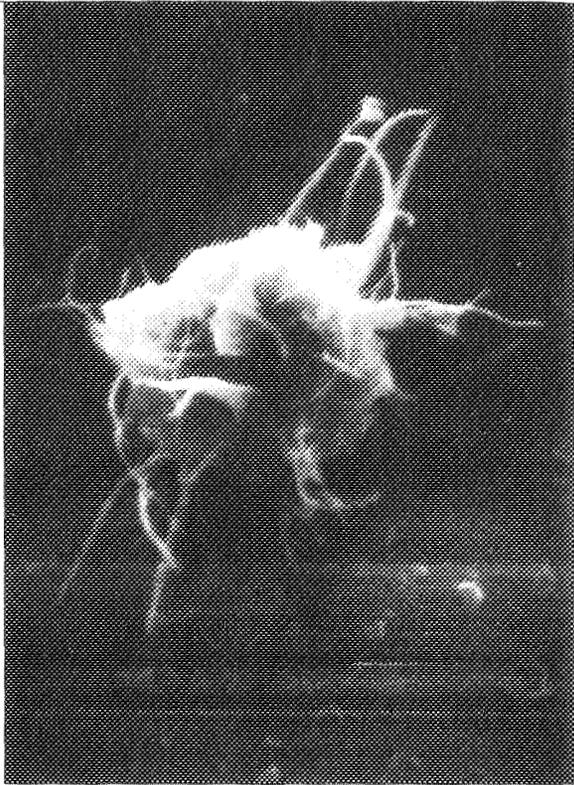
FIGURE 2.—Scanning electron microscope photograph of the particle in figure 1. Note the structural change in the whiskers caused by the vacuum deposition processes.

A previously unreported feature of lunar fines is the existence of filamentary whisker-like objects attached to individual particles in a manner resembling sea urchins. Twenty particles were found on the red optical filter with whiskers averaging 10 μm long and 0.1 μm wide. It is hypothesized that these whiskers grew on the particles during impact events on the lunar surface. If this explanation is correct, then determination of the fraction of lunar particles that contain whiskers may allow setting limits to theories that predict migration of dust over the lunar surface by various processes. These features presumably have not been observed before because of their friability.
